4.0 Addendum – reinstatement of complete sundial.

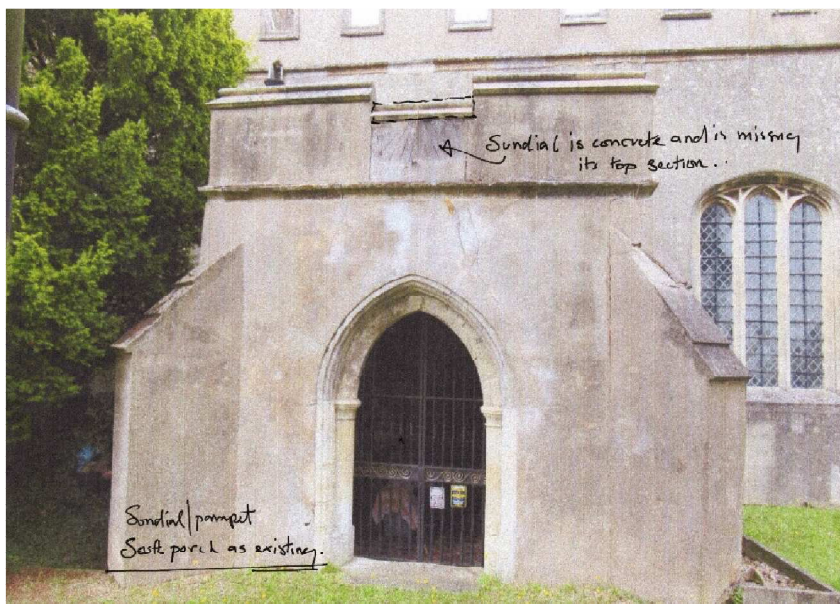
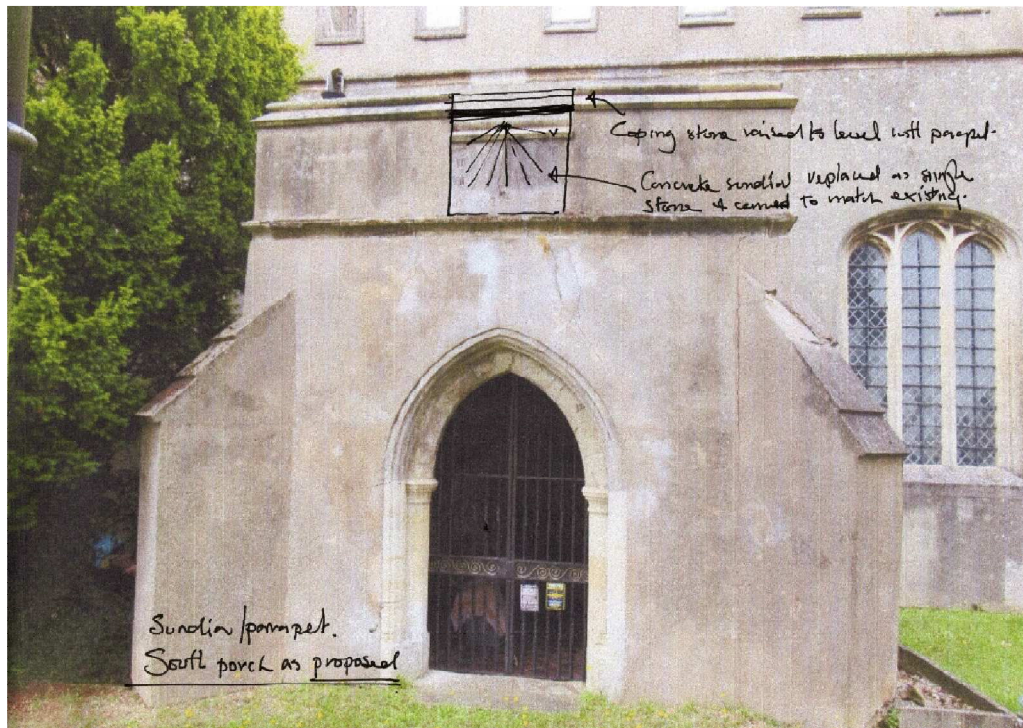
Sundial – parapet as proposed

- 4.1 Carefully remove coping stone from over sundial and set aside.
- 4.2 Record the detail on the face of the concrete sundial and remove it.
- 4.3 Repair backing brickwork and raise up in sound well burnt stock bricks level with the walls on either side. Tie into side walls with ss mesh or ss brick ties.
- 4.4 Supply and fix new sundial as single slab of Stoke Ground base bed, 50mm thick and secure to new and existing brick backing with ss dowels and a backing bedding of lime mortar.

New sundial to match existing detail and to include the missing detail as shown in sketch and photograph.

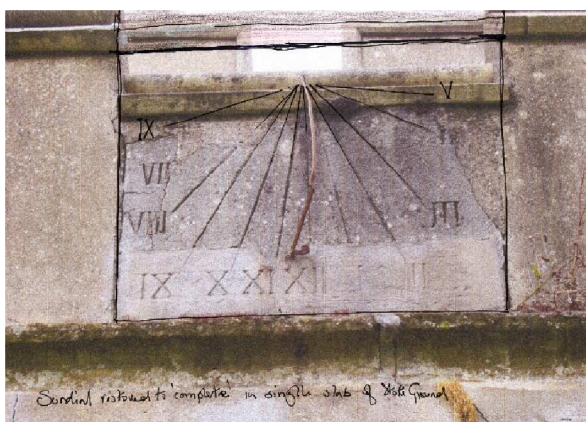
Sundial as proposed -

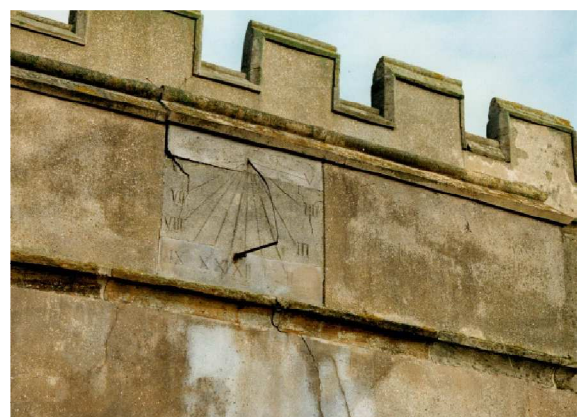
- and as it used to be 1994

- 4.5 Replace and seat existing coping stone to be level with coping stones on either side.
